Manhole Inspection Summary

Manhole # S69S__005MH

Insp Date: **4/4/08 10:40 AM**

Location Address: **6526 Eastbourne Ave.**

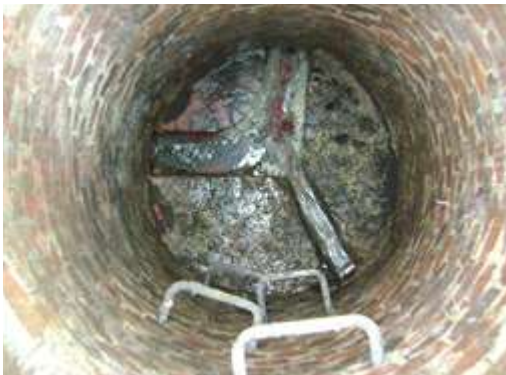
Defect 1

Condition: ☐ Sound ☐ Cracked ☐ Root Intrusion ☐ Deteriorated ☐ Leaks ☒ **Debris**

Debris on bench

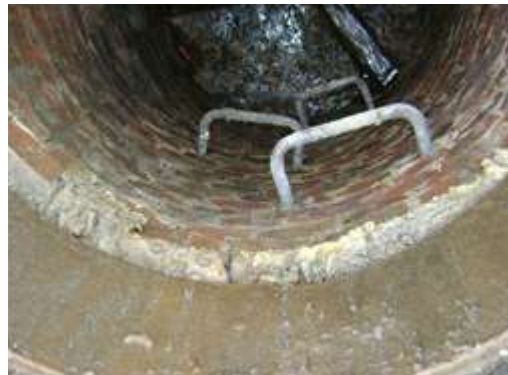
Defect 2

Condition: ☐ Sound ☐ Cracked ☐ Root Intrusion ☒ **Loose Brick** ☒ **Deteriorated**

Infiltration: ☐ None ☐ Joint ☐ Cracks ☒ **Mortar** ☐ Roots ☐ Wall

Deteriorating chimney and loose bricks

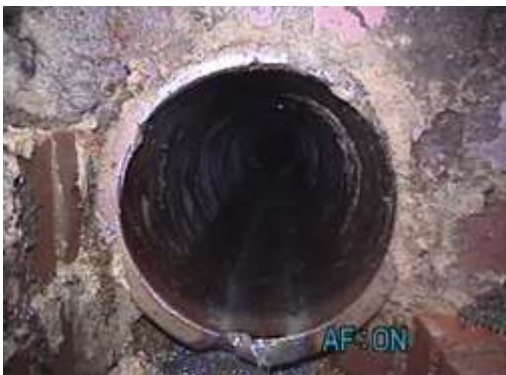
Defect 3

Cracked pipe at 9 in, at 6oclock

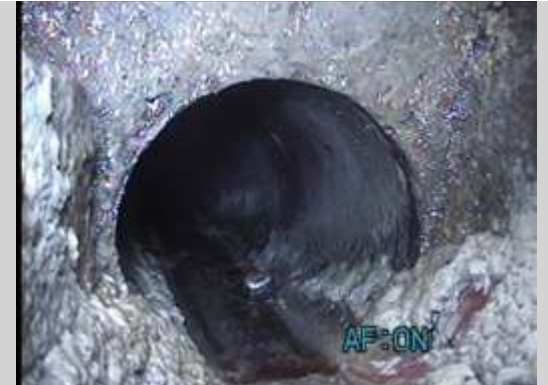
12 O'Clock Outflow

Pipe Height: **8.4** (in.) Rod and Bar (Angled)
Pipe Material: **Clay** ☐ Pipe Lined
Invert Depth: **8.75** (ft.) Flow Characteristics: **Slow**
Deposits: ☒ None ☐ Mud ☐ Sludge ☐ Debris ☐ Grease
Silt Depth: (in.) Deposits Extent:
Infiltration: **None** Pipe Seal Cond: **Sound**

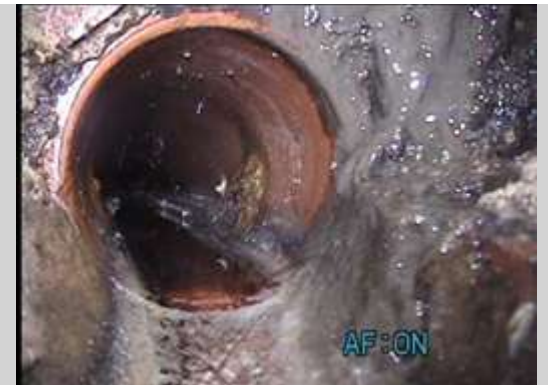
5 O'Clock Inflow

Pipe Height: **6** (in.) Rod and Bar (Angled)
Pipe Material: **Clay** ☐ Pipe Lined
Invert Depth: **7.83** (ft.) Flow Characteristics: **Slow**
Deposits: ☒ None ☐ Mud ☐ Sludge ☐ Debris ☐ Grease
Silt Depth: (in.) Deposits Extent:
Infiltration: **None** Pipe Seal Cond: **Sound**

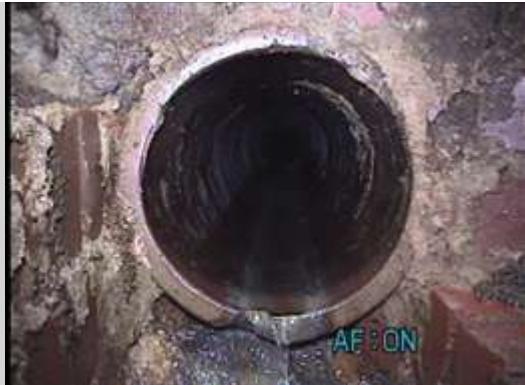
9 O'Clock Inflow

Pipe Height: **8.4** (in.) Rod and Bar (Angled)

Infiltration: **None** Pipe Seal Cond: **Sound**
